## 5.BDA-2025-00414

307 N. Taylor Avenue Mexican War Streets Historic District Central Northside Neighborhood Restoration of commercial façade along N. Taylor Avenue

# 307 N TAYLOR /1315 SHERMAN AVENUE

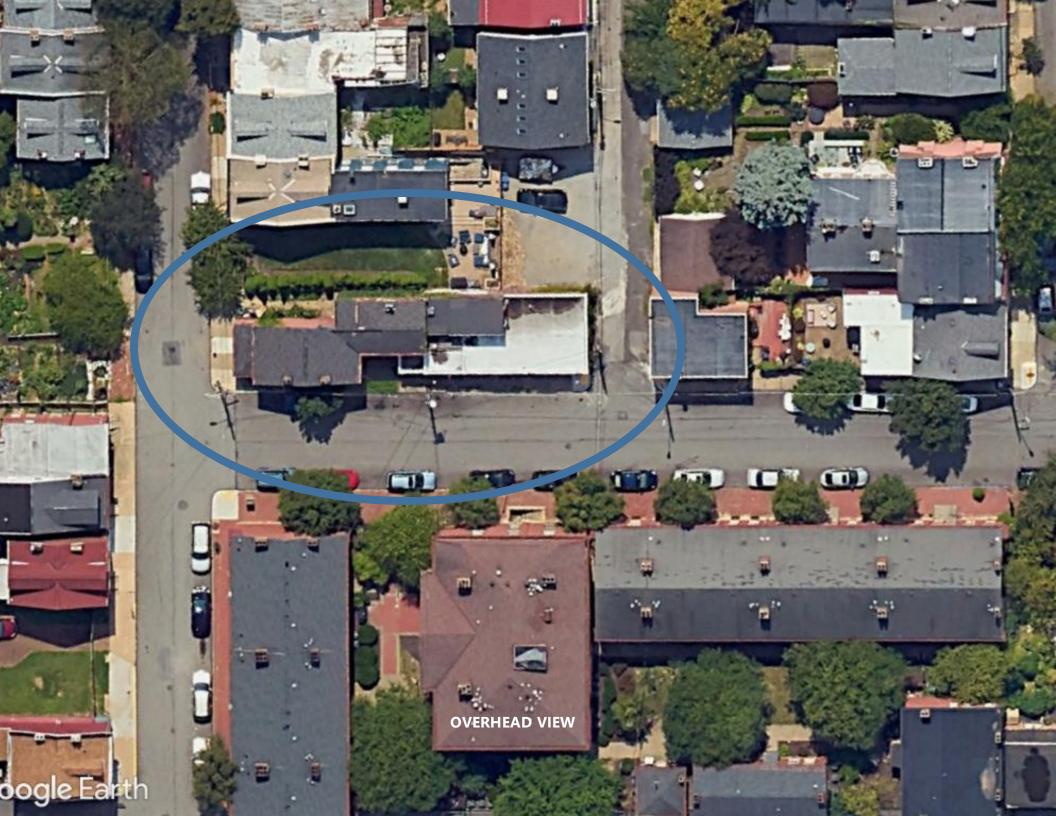
### **EXISTING FACADE DETAILS**

ORIGINALL OPENINGS WILL BE REOPENED, NEW WOOD STOREFRONTS WILL BE INSTALLED, NEW DOORS WILL BE INSTALLED, BRICK WILL BE REPOINTED AND PAINTED

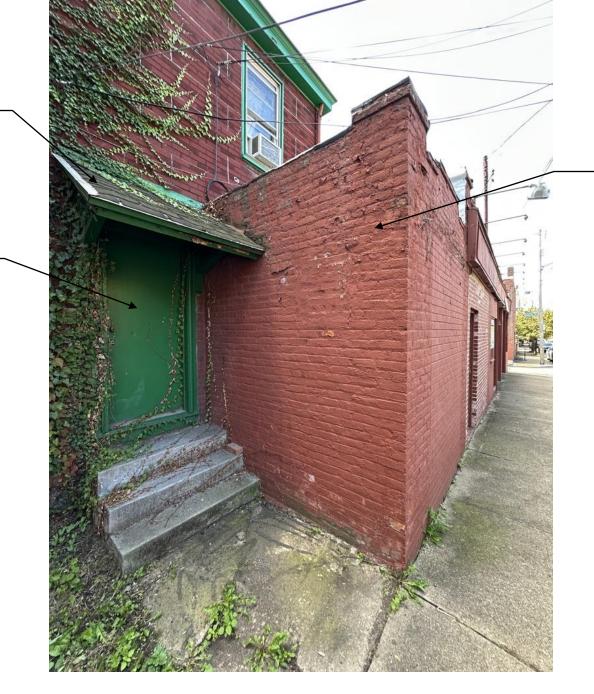
**NORTHEAST CORNER**

EXISTING ROOF TO BE-REMOVED

EXISTING DOOR TO BE-REMOVED, NEW WOOD AND GLASS DOOR TO BE INSTALLED BRICK TO BE REPOINTED AND REPAINTED, NEW LIMESTONE COPING

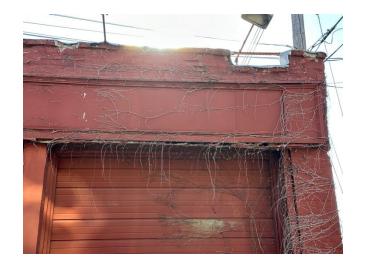
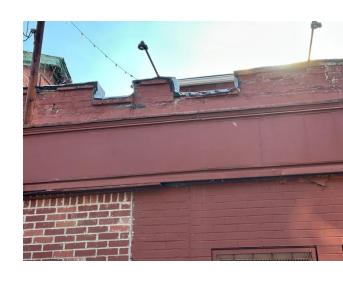
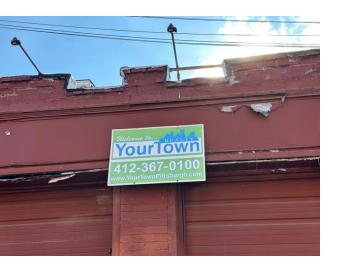
### **EXISTING PARAPET DETAILS**

EXISTING COPINGS WILL BE REMOVED, NEW LIMESTONE COPINGS WILL BE INSTALLED, BRICK WILL BE REPOINTED AND PAINTED
